HEDBOX
PRODUCT RELIABILITY TESTING
of the NERO S and NERO L
Report No. 112-19-0033A
Proposal No. 54338 Rev. B

Product: NERO S and NERO L

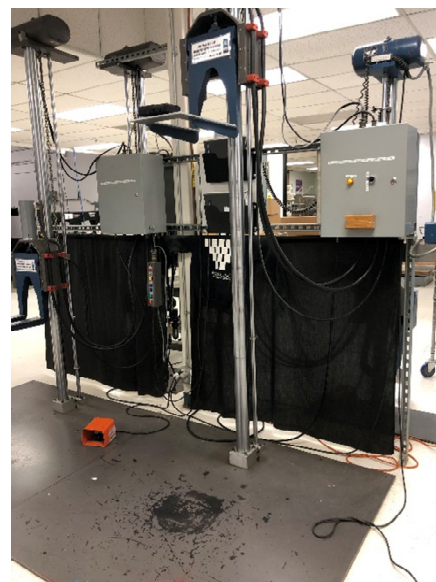
Number of samples: 4
EUT status: Non-Operational
Impact surface: Steel

Drop Number	Unit	Orientation	Drop Height	
			in	cm
1	NERO S Unit #1	Face Down	70	178
2		Top Down		
3		Left Down		
4	NERO S Unit #2	Top-Back Corner		
5	NERO L Unit #1	Face Down		
6		Top Down		
7		Left Down		
8	NERO L Unit #2	Top-Back Corner

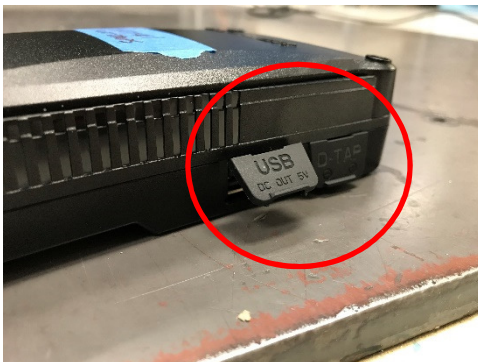
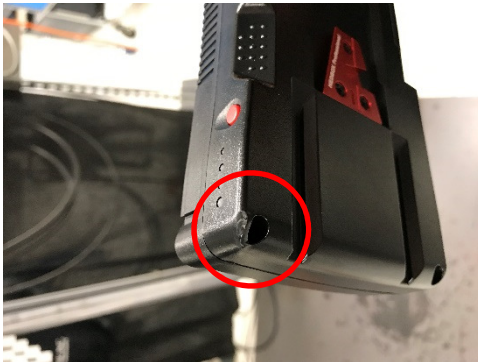
<p>NERO L</p>

Test Input	Observations	Appendix
Freefall Drop	<p>No unusual physical damage was observed to the exterior of the units following this test input.</p> <p>Port covers popped open during drops, loose particles were heard on the interior of the enclosure, and minor dents observed to the corner of the units following corner impacts.</p> <p>Please refer to the photos below for these observations.</p>

No unusual external physical damage was observed to the units throughout the test input. Port covers popped open during drops, loose particles were heard on the interior of the enclosure, and minor dents observed to the corner of the units following corner impacts.
